### Mold Remediation Protocol

Project Address: [REDACTED]

Date of Initial Assessment: **June 24, 2021**

Remediation Protocol Date: **October 21, 2021**

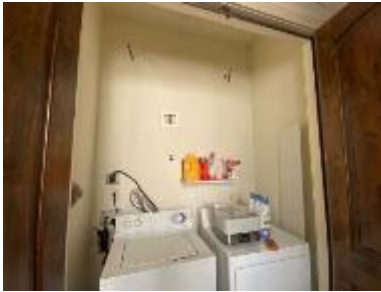
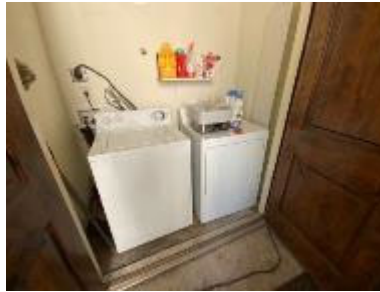
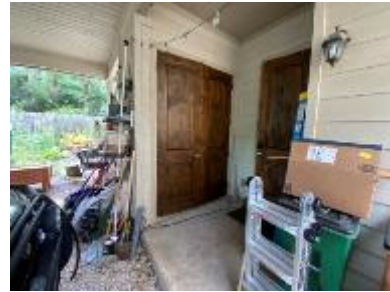
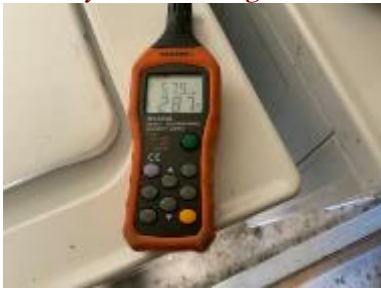
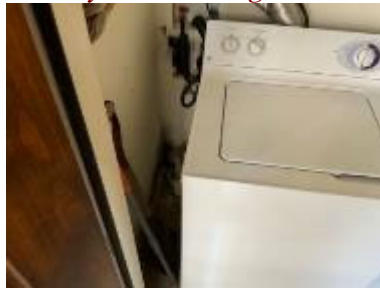
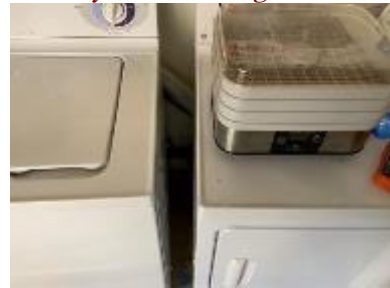
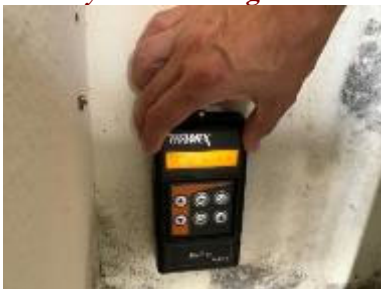
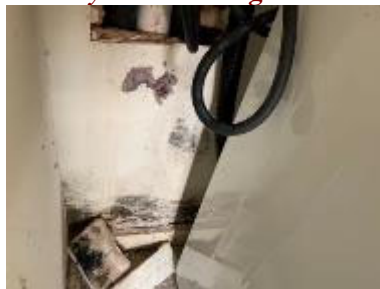
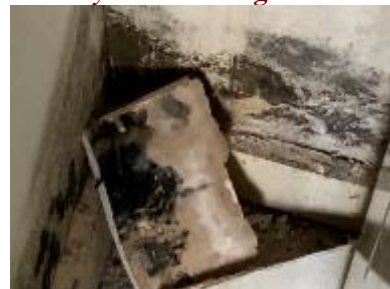
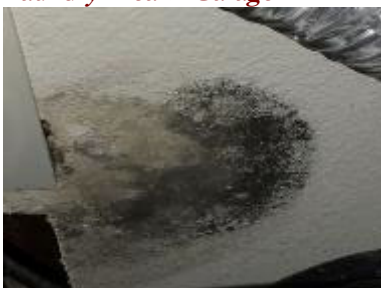
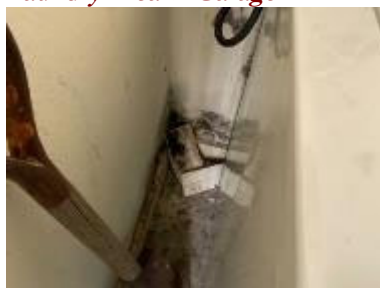
*Laundry Area in Garage*

**1.2.1 Laundry Area in Garage and adjacent Living Room wall** – Visual inspection revealed mold growth at the walls in the Laundry Area in Garage. Elevated moisture was present on the walls in the Laundry Area in Garage and adjacent wall in Living Room. Visible contamination covered an area <25 square feet.

Room/Area	Remediation Instructions
<p>Laundry Area in Garage</p> <p>Adjacent walls to include Living Room</p> <p>SEE DIAGRAM</p>	<ol style="list-style-type: none"> <li>1. Remove all furniture and contents from areas to be contained.</li> <li>2. Erect a Limited Containment for each area/room, and install critical barriers over all openings – lights, plumbing penetrations, a/c vents, etc. Establish negative pressure, which must be maintained until Clearance. Exhaust to the exterior, if possible.</li> <li>3. Place dehumidifiers as needed to facilitate proper dry-out. All wood materials should be 15% moisture content or less to be considered “dry” at the time of the Clearance Inspection.</li> <li>4. <b>Remove baseboards and door casings in affected areas as shown on the Diagram.</b></li> <li>5. <b>Remove impacted wall materials as shown on the Diagram. Inspect remaining materials, if impacted or damaged, remove and dispose of accordingly 1-2 feet past the last visible impact.</b></li> <li>6. Remove and dispose of any exposed insulation. Open wall and ceiling cavities with insulation must be sealed off.</li> <li>7. Remove and replace all water-damaged, rotten wood materials. Wood rot <u>MUST</u> be removed to pass Clearance.</li> <li>8. Clean in place structurally sound framing, flooring, ceiling joists, metal and other wood structures by sanding, grinding, or wire brushing. This treatment must remove all fungal growth from the affected materials.</li> <li>9. HEPA vacuum all surfaces.</li> <li>10. Wipe down all surfaces with a detergent solution or EPA registered fungicide as a final remedial treatment.</li> <li>11. Reduce airborne particulate concentrations inside the contained area(s). Scrub air using HEPA filtration units. Time allowed for scrubbing should be determined by the CFM ratings of the units being used and the corresponding size of the contained area and amount of mold removed.</li> </ol> <p style="text-align: center;"><b>ESTIMATED AMOUNT OF MATERIAL TO BE REMOVED:</b></p> <p style="text-align: center;">DRYWALL – 120 SF</p>

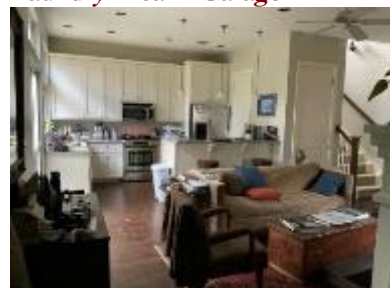
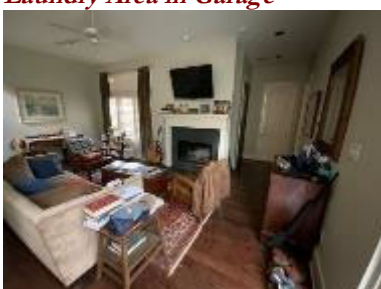
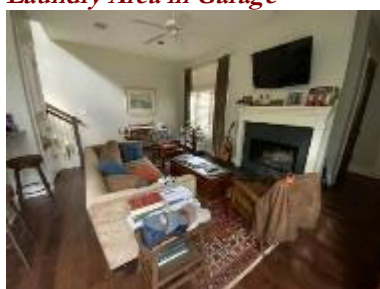
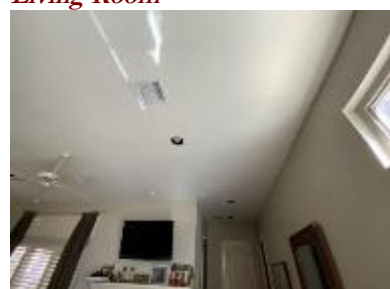
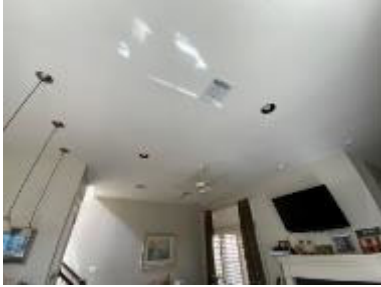
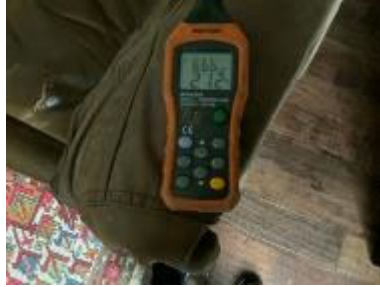
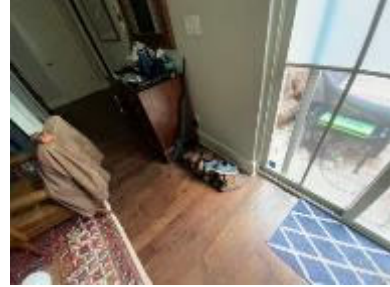
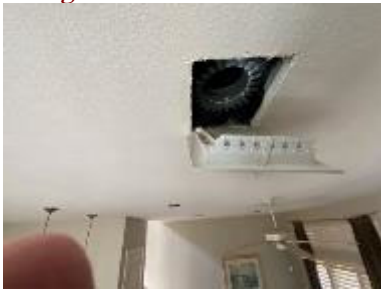
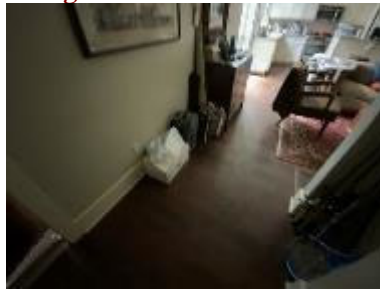
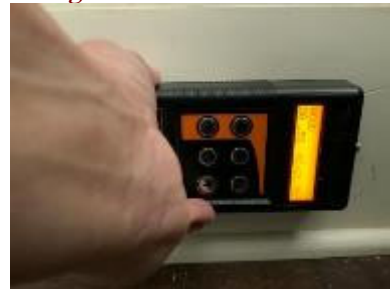
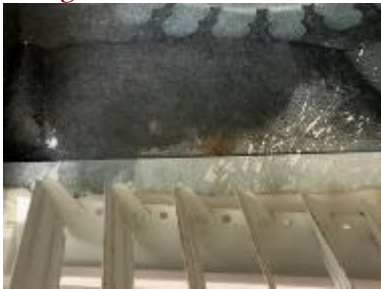
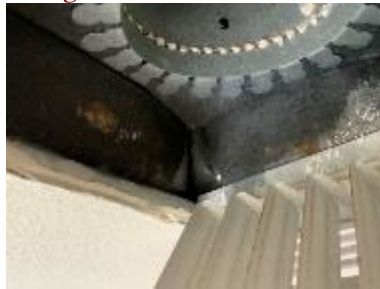
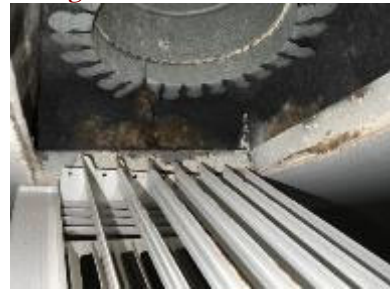
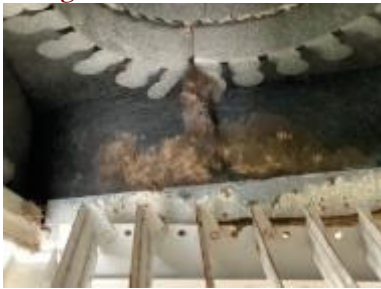
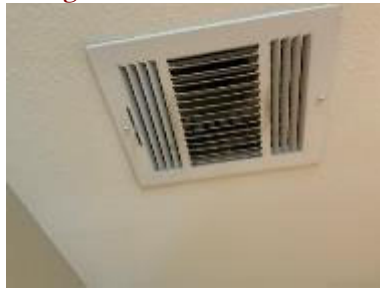
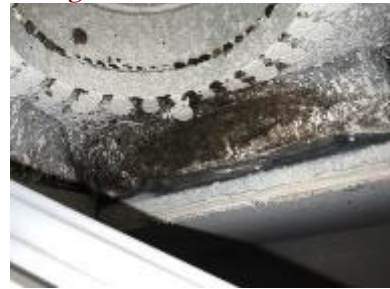
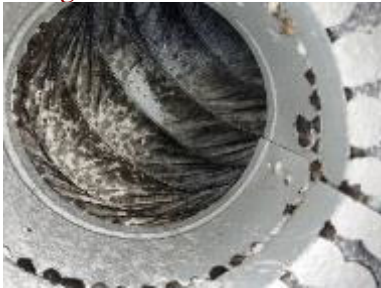
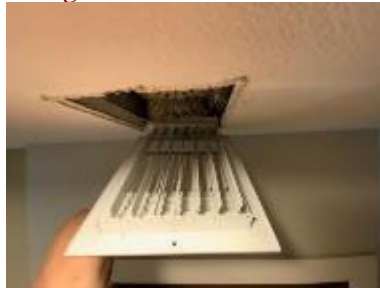
*Living Room*

**1.2.2 HVAC supply components in Living Room and Hall Bathroom (Powder)** – Visual inspection revealed mold growth. Visible contamination covered an area <25 square feet.

Room/Area	HVAC System Remediation Instructions
<b>HVAC System</b>  <b>Including the Following Rooms/Areas:</b>  <b>Living Room</b>  <b>Hall Bathroom (Powder)</b>	13. Erect a Containment around each supply duct penetration in each room. If drywall removal is required, allow enough room to remove 1-2 feet of drywall (8-16 SF) around the vent penetration. 14. Remove and dispose of all mold impacted ductwork and diffuser boxes in the following areas: <ol style="list-style-type: none"> <li>1. Hall Bathroom (Powder)</li> <li>2. Living Room – North and East Supply</li> </ol> 15. Clean remaining ductwork for areas listed above, if possible; otherwise, replace all ductwork. 16. Remove and dispose of any exposed insulation. Open wall and ceiling cavities with insulation must be sealed off. 17. Clean in place structurally sound framing, ceiling joists, other wood structures by sanding, grinding, or wire brushing. This treatment must remove all fungal growth from the affected materials. 18. HEPA vacuum all surfaces. 19. Reduce airborne particulate concentrations inside the containments. Scrub the air using HEPA filtration units.
